FIGURE 1. EVALUATION OF SLIDING DOOR GAP SEPARATION

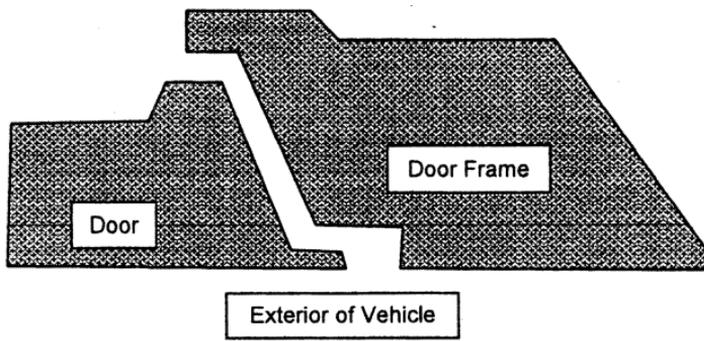
Top View – Pre Test

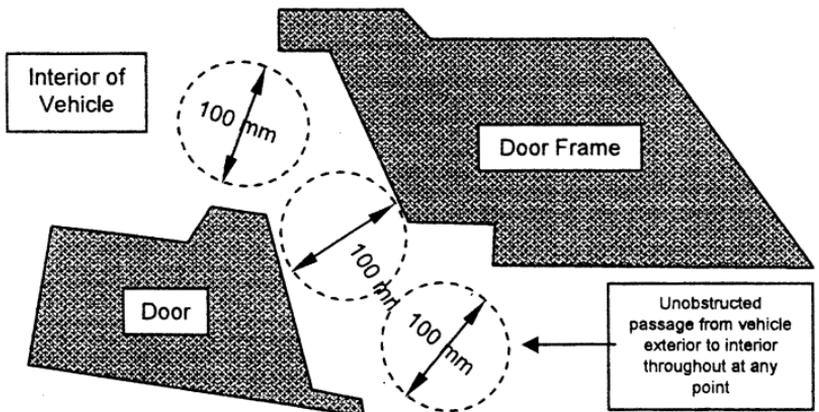
Top View – During Force Application
