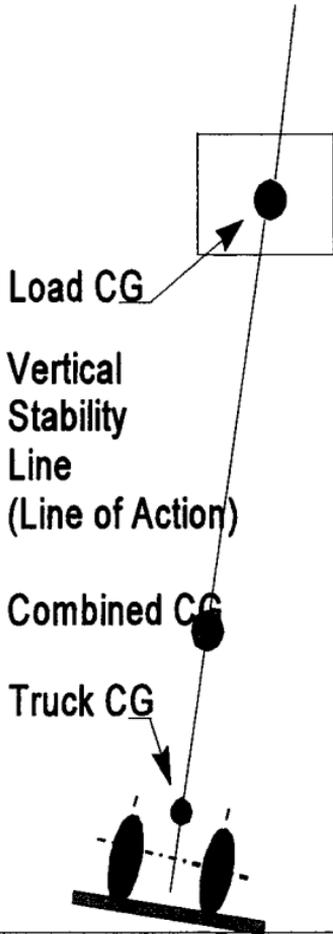
Figure 2.

Load CG

Vertical  
Stability  
Line  
(Line of Action)

Combined CG

Truck CG

The vehicle is stable

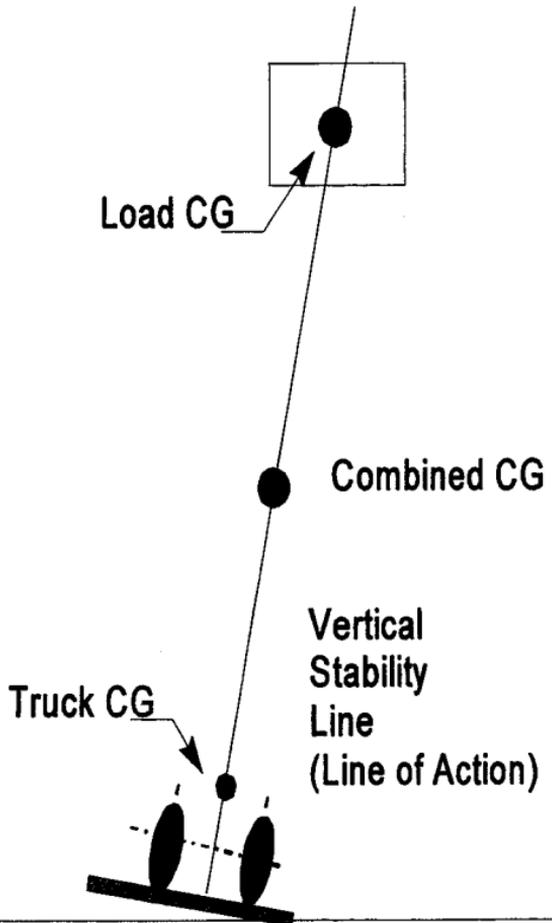
Load CG

Combined CG

Vertical  
Stability  
Line  
(Line of Action)

Truck CG

This vehicle is unstable and  
will continue to tip over
