FIGURE 7

SPLICE LOSS CAUSED BY FIBER MANUFACTURE

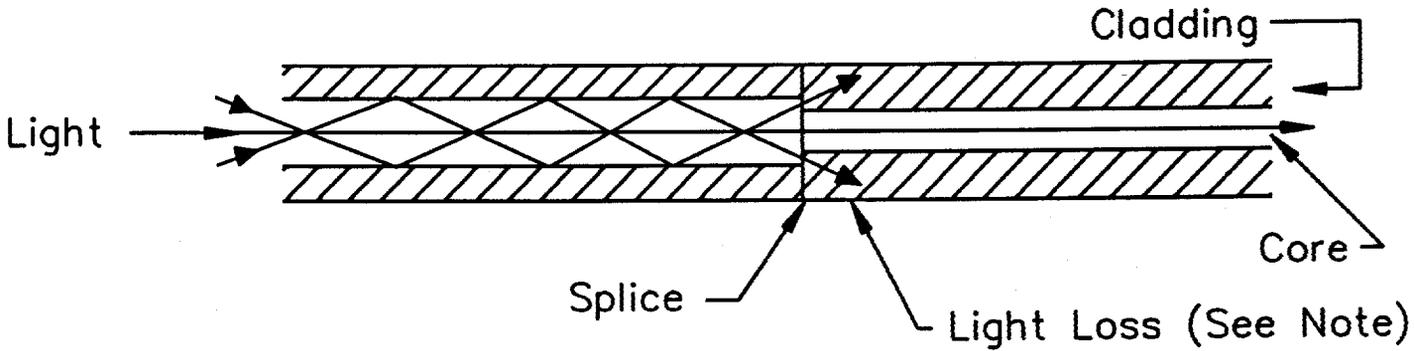
Different Core Diameters

Note: There is no light loss if the light travels from a smaller to a larger core.

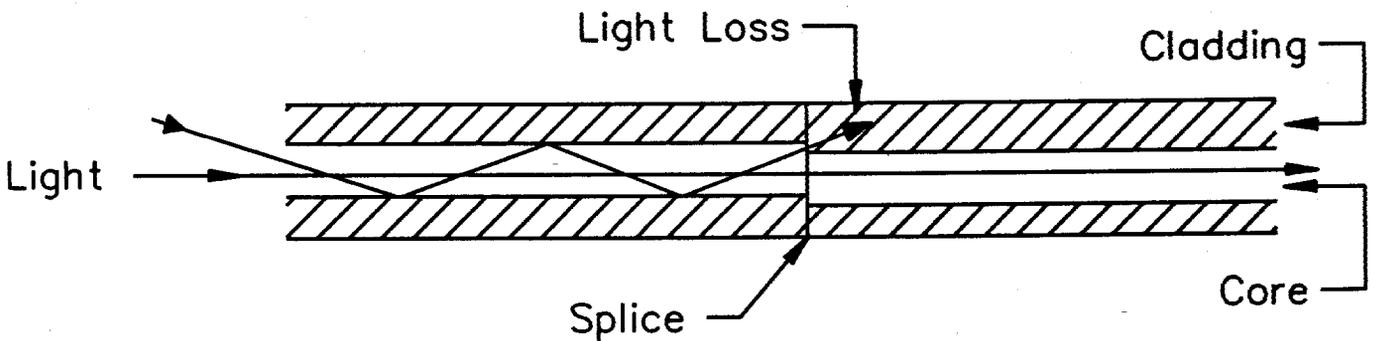
Core Not In The Center Of Fiber

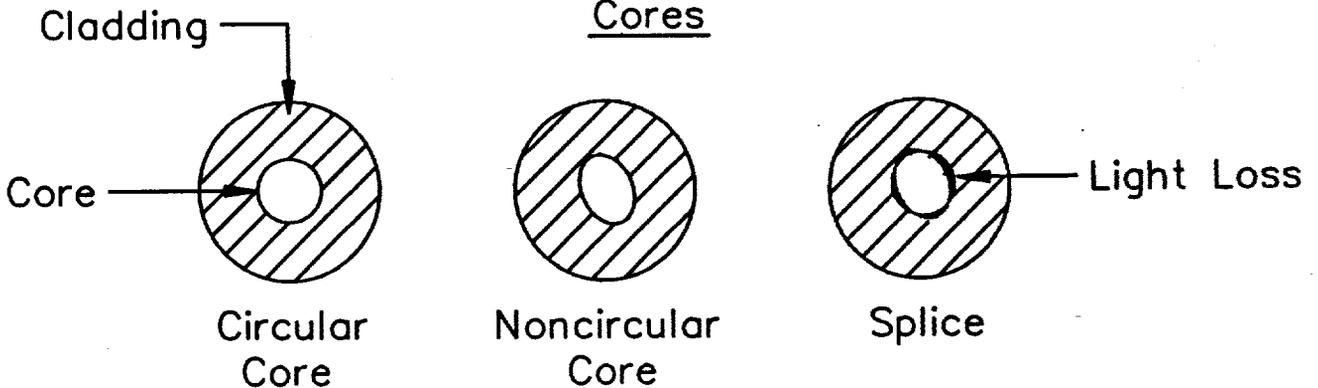
Cores
